Alternative Design of Abutment Damage Management for Glendeng Bridge Tuban Regency

Alfanditya Ghazanfar^{1*}, Moh. Muntaha², Machsus Machsus³

¹⁻³Master of Applied Study Programme in Engineering Maintenance and Restoration of Civil Structures Study Program Departemen Civil Infrastructure Engineering, Faculty of Vocational Studies, Institut Teknologi Sepuluh Nopember, Surabaya Indonesia

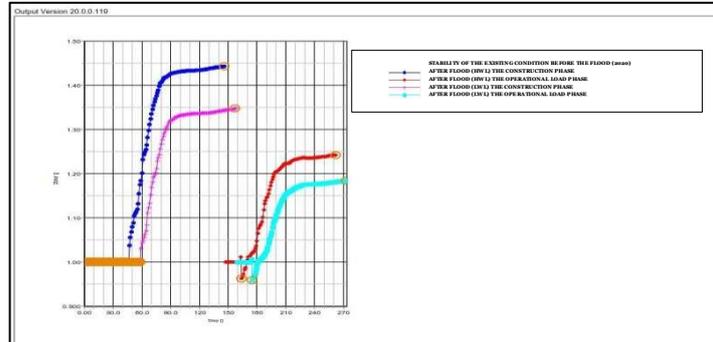
Figure 2. Graph of Factor of Safety Based on Stability Analysis of Existing Conditions Before the 2020 Flood

Based on the results of the analysis of the stability of the existing bridge structure before the flood at each stage, the safety factor value is obtained as follows:

1. Before the flood event (HWL) bridge construction stage, $SF = 1.443$
2. Before the flood event (HWL) load operational stage, $SF = 1.243$
3. Before the flood event (LWL) bridge construction stage, $SF = 1.347$
4. Before flood event (LWL) operational load stage, $SF = 1.184$

The comparison graph above is the result of the Plaxis software analysis at all stages of the pre-flood condition analysis or under normal conditions with the existing parameters showing that none of the stage conditions reach the $SF = 1.5$ value so that the existing conditions in 2020 already have a low SF value.

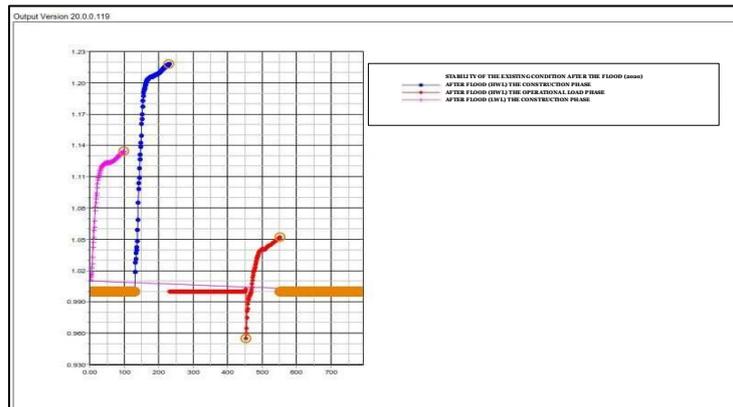
Figure 3. Graph of Factor of Safety Based on Stability Analysis of Existing Conditions After the 2020 Flood

Based on the results of the above analysis, the value of $SF = 1.052$ is obtained in the analysis of the operational stage of the load with conditions when the water level is flooded (HWL) while in the operational stage of the load with normal water level conditions, the structure experiences landslides when it is noted that landslides occur when the water level is normal, this is because there is a factor that is rapid drawdown so that it can affect the stability of the slope and surrounding structures. Rapid drawdown is a rapid decrease in water level elevation that affects the condition of slopes and nearby structures. This decrease can leave a saturation effect on the soil so that the soil parameters are assumed to decrease and overload the retaining wall structure, causing landslides.

Based on the results of the analysis of the stability of the existing bridge structure after flooding at each stage, the safety factor value is obtained as follows:

- 1) After the flood event (HWL) bridge construction stage, $SF = 1.218$
- 2) After the flood event (HWL) load operational stage, $SF = 1.052$
- 3) After flood event (LWL) bridge construction stage, $SF = 1.134$
- 4) After the flood event (LWL) load operational stage, structural failure occurs

The comparison graph above is the result of the Plaxis software analysis at all stages of the condition analysis after a flood or with the existing parameters showing the load stage experiencing landslides when the spring water is in the normal water level $SF = -$ so that this existing condition correlates with the evaluation related to damage in 2020, namely the elevation of the flood water level affects the resistance force on slope stability. When the water level drops suddenly or rapid drawdown, landslides occur because the soil properties have changed to saturation due to the flooding that occurred.

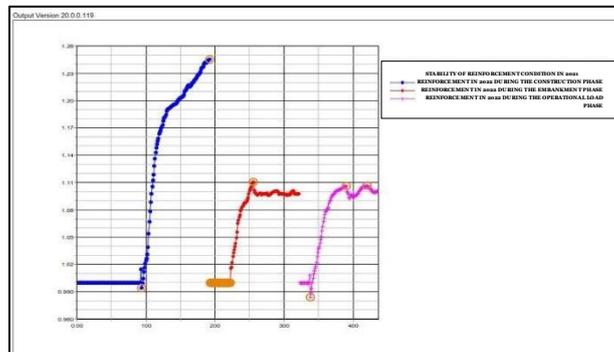
Figure 4. Safety Factor Graph Based on Stability Analysis of Reinforcement Condition 2021

Based on the results of data analysis before the 2020 flood, the value of SF = 1.243 was obtained at the operational stage of the load, while in 2021 in the retrofitting analysis, the value of SF = 1.245 was obtained. At the construction stage, the SF value continues to decrease with the addition of fill on the lower side of the bridge abutment so that SF = 1.097 is obtained. This causes a decrease in the side of the abutment so that the abutments and pillars of the approach bridge experience a decrease and elevation difference and require bridge rehabilitation to prevent sliding that occurs.

Based on the results of analyzing the stability of the bridge structure under reinforced conditions in 2021 at each stage, the safety factor value is obtained as follows:

- 1) Reinforcement 2021 Bridge construction stage, SF = 1.245
- 2) Reinforcement 2021 Bridge and embankment construction stage, SF = 1.097
- 3) 2021 Retrofitting Load operational stage, SF = 1.101

Based on the above graph at the existing construction stage in 2021, the SF value = 1.245 is obtained so that these results are still considered "Critical" because they are still <1.5

so that the existing conditions require handling related to the reinforcement that has been built.

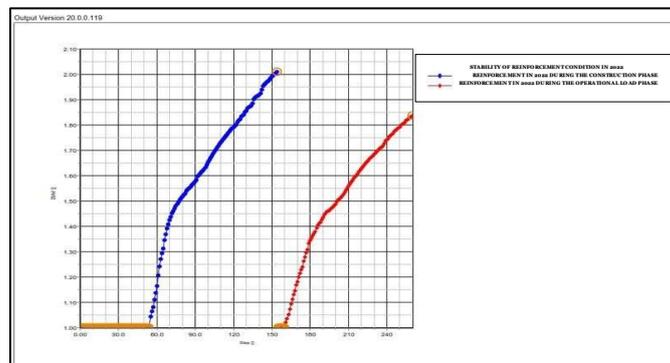
Figure 5. Graph of Factor of Safety Based on Stability Analysis of Reinforcement Condition 2022

The results of the data analysis above show that the SF value at the operational stage of the reinforcement load in 2022 has decreased, the SF value = 1.838 is categorized as "Safe" according to (Bowles, 1984). However, in its implementation, this construction cost approximately 23 billion and had experienced obstacles until the work had to be completed until the beginning of 2024 due to these cost problems.

Based on the results of analyzing the stability of the bridge structure under reinforced conditions in 2022 at each stage, the safety factor value is obtained as follows:

- 1) Reinforcement 2022 Bridge construction stage, SF = 2.009
- 2) Reinforcement 2022 Load operational stage, SF = 1.838

The graph of the analysis results obtained by the reinforcement built by the Tuban district government has increased FS = 2.009 even though the load operational stage analysis was carried out, the SF = 1.838 value proves that the reinforcement that has been built has succeeded in keeping the Glendeng Bridge structure safe even though the efficiency of workmanship and costs is still considered very large.

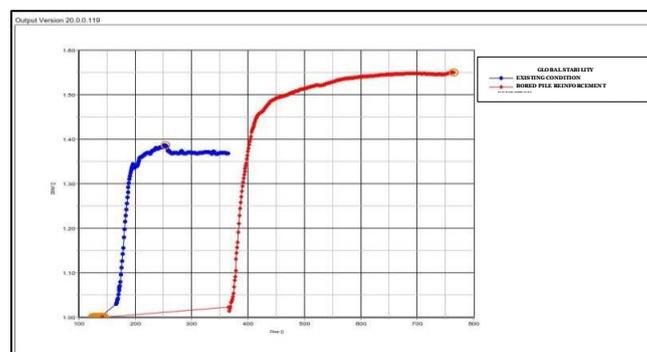
Figure 6. Graph of Safety Factor Based on Stability Analysis of Handling Alternatives

Based on the results of the analysis of the existing Plaxis software used in the analysis of this alternative treatment using the existing 2021 reinforcement which was damaged and resulted in a value of SF = 1.097 at the construction and embankment stages but the increase in the safety factor after bored pile was implanted as an alternative treatment was SF = 1.551 and the total displacement that occurred was 0.069 m, indicating that the reinforcement structure using Contiguous Bored Pile Wall can be categorized as "Safe / High" according to SNI - 8460 of 2017 concerning "Geotechnical Planning" this handling is also more economical only spending a budget of ± 3 billion Rupiah.

Based on the results of analyzing the stability of the bridge structure at each stage of construction, the safety factor value is obtained as follows:

- 1) Existing Bridge Construction Stage, SF = 1.368 < 1.50
- 2) Construction Stage of Strengthening the Bridge Structure, SF = 1.551 > 1.50.

It is planned to use a Contiguous Bored Pile Wall with a diameter of 1 meter, a pile length of 30 meters, and concrete quality (f_c') of 30 MPa. To address the landslide, the Contiguous Pile Wall will consist of bored piles with the same diameter and concrete specifications, along with a pile cap to stabilize the retaining wall. After the installation of the bored piles, the safety factor increases to $SF = 1.551$, with a total displacement of 0.069 meters, indicating that the structure with the Contiguous Bored Pile Wall is "Safe/High," according to the SNI 8460:2017 standards on Geotechnical Design. Several suggestions for further research on the handling of damage to the Glendeng Bridge Abutment include evaluating alternative materials for bridge rehabilitation to optimize cost and efficiency in the budget planning process, ensuring a thorough understanding and study of any software program used in research and analysis to facilitate smoother implementation.
