# Alternative Design of Abutment Damage Management for Glendeng Bridge Tuban Regency

**Alfanditya Ghazanfar<sup>1\*</sup>, Moh. Muntaha<sup>2</sup>, Machsus Machsus<sup>3</sup>**

<sup>1-3</sup>Master of Applied Study Programme in Engineering Maintenance and Restoration of Civil Structures Study Program Departemen Civil Infrastructure Engineering, Faculty of Vocational Studies, Institut Teknologi Sepuluh Nopember, Surabaya Indonesia

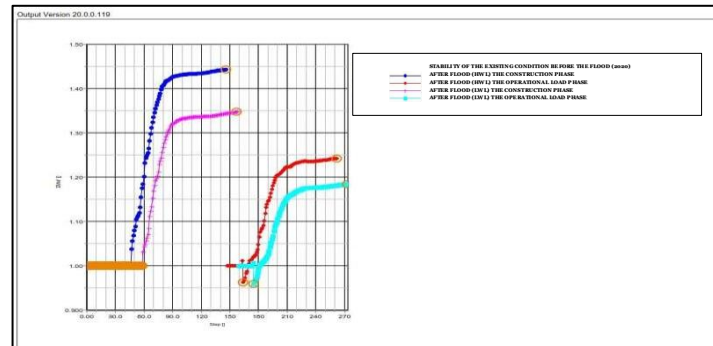
**Figure 2. Graph of Factor of Safety Based on Stability Analysis of Existing Conditions Before the 2020 Flood**

Based on the results of the above analysis, the value of  $SF = 1.443$  is obtained in the analysis of the operational stage of the load with conditions when the flood water level (HWL) while in the operational stage of the load with normal water level conditions, the value of the

safety factor decreases  $SF = 1.347$  the increase in the SF value during flood conditions lies in the flood water elevation factor. The high water level elevation will increase the hydrosecurity pressure acting on the river cross section, thus increasing the magnitude of the resisting force element in resisting the driving force element in the form of soil mass from the river slope.

1. Before the flood event (HWL) bridge construction stage,  $SF = 1.443$
2. Before the flood event (HWL) load operational stage,  $SF = 1.243$
3. Before the flood event (LWL) bridge construction stage,  $SF = 1.347$
4. Before flood event (LWL) operational load stage,  $SF = 1.184$

The comparison graph above is the result of the Plaxis software analysis at all stages of the pre-flood condition analysis or under normal conditions with the existing parameters showing that none of the stage conditions reach the  $SF = 1.5$  value so that the existing conditions in 2020 already have a low SF value.

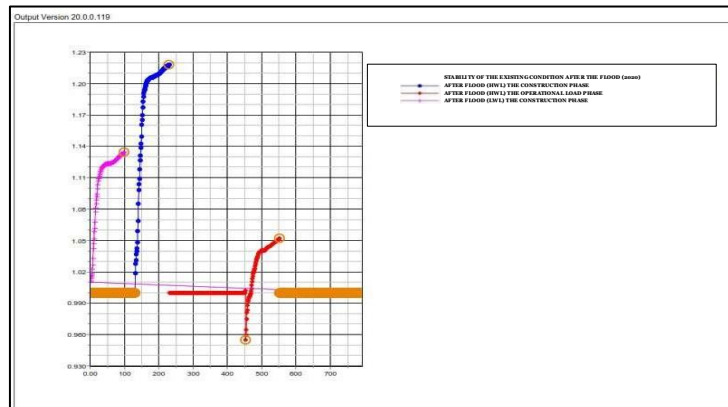
**Figure 3. Graph of Factor of Safety Based on Stability Analysis of Existing Conditions After the 2020 Flood**

Based on the results of the above analysis, the value of  $SF = 1.052$  is obtained in the analysis of the operational stage of the load with conditions when the water level is flooded (HWL) while in the operational stage of the load with normal water level conditions, the structure experiences landslides when it is noted that landslides occur when the water level is normal, this is because there is a factor that is rapid drawdown so that it can affect the stability of the slope and surrounding structures. Rapid drawdown is a rapid decrease in water level elevation that affects the condition of slopes and nearby structures. This decrease can leave a saturation effect on the soil so that the soil parameters are assumed to decrease and overload the retaining wall structure, causing landslides.

- 1) After the flood event (HWL) bridge construction stage,  $SF = 1.218$
- 2) After the flood event (HWL) load operational stage,  $SF = 1.052$
- 3) After flood event (LWL) bridge construction stage,  $SF = 1.134$
- 4) After the flood event (LWL) load operational stage, structural failure occurs

The comparison graph above is the result of the Plaxis software analysis at all stages of the condition analysis after a flood or with the existing parameters showing the load stage experiencing landslides when the spring water is in the normal water level  $SF = -$  so that this existing condition correlates with the evaluation related to damage in 2020, namely the elevation of the flood water level affects the resistance force on slope stability. When the water level drops suddenly or rapid drawdown, landslides occur because the soil properties have changed to saturation due to the flooding that occurred.

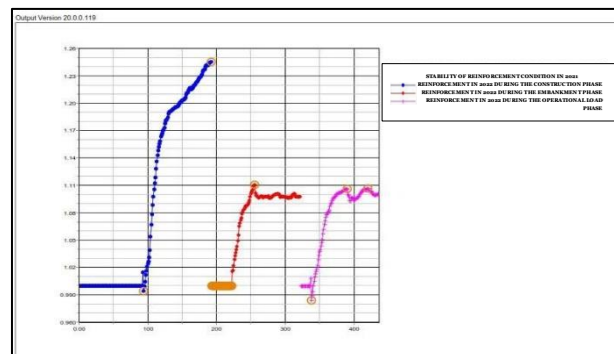
**Figure 4. Safety Factor Graph Based on Stability Analysis of Reinforcement Condition 2021**

Based on the results of data analysis before the 2020 flood, the value of SF = 1.243 was obtained at the operational stage of the load, while in 2021 in the retrofitting analysis, the value of SF = 1.245 was obtained. At the construction stage, the SF value continues to decrease with the addition of fill on the lower side of the bridge abutment so that SF = 1.097 is obtained. This causes a decrease in the side of the abutment so that the abutments and pillars of the approach bridge experience a decrease and elevation difference and require bridge rehabilitation to prevent sliding that occurs.

- 1) Reinforcement 2021 Bridge construction stage, SF = 1.245
- 2) Reinforcement 2021 Bridge and embankment construction stage, SF = 1.097
- 3) 2021 Retrofitting Load operational stage, SF = 1.101

Based on the above graph at the existing construction stage in 2021, the SF value = 1.245 is obtained so that these results are still considered "Critical" because they are still <1.5

so that the existing conditions require handling related to the reinforcement that has been built.

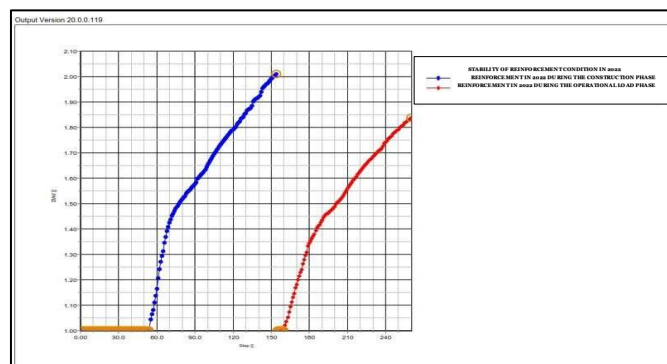
**Figure 5. Graph of Factor of Safety Based on Stability Analysis of Reinforcement Condition 2022**

The results of the data analysis above show that the SF value at the operational stage of the reinforcement load in 2022 has decreased, the SF value = 1.838 is categorized as "Safe" according to (Bowles, 1984). However, in its implementation, this construction cost approximately 23 billion and had experienced obstacles until the work had to be completed until the beginning of 2024 due to these cost problems.

- 1) Reinforcement 2022 Bridge construction stage, SF = 2.009
- 2) Reinforcement 2022 Load operational stage, SF = 1.838

The graph of the analysis results obtained by the reinforcement built by the Tuban district government has increased FS = 2.009 even though the load operational stage analysis was carried out, the SF = 1.838 value proves that the reinforcement that has been built has succeeded in keeping the Glendeng Bridge structure safe even though the efficiency of workmanship and costs is still considered very large.

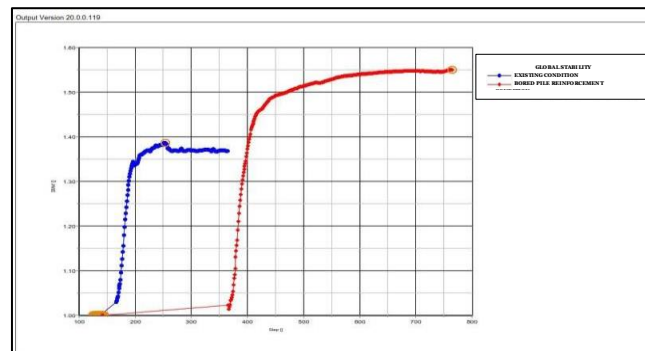
**Figure 6. Graph of Safety Factor Based on Stability Analysis of Handling Alternatives**

Based on the results of the analysis of the existing Plaxis software used in the analysis of this alternative treatment using the existing 2021 reinforcement which was damaged and resulted in a value of  $SF = 1.097$  at the construction and embankment stages but the increase in the safety factor after bored pile was implanted as an alternative treatment was  $SF = 1.551$  and the total displacement that occurred was 0.069 m, indicating that the reinforcement structure using Contiguous Bored Pile Wall can be categorized as "Safe / High" according to SNI - 8460 of 2017 concerning "Geotechnical Planning" this handling is also more economical only spending a budget of  $\pm 3$  billion Rupiah.

- 1) Existing Bridge Construction Stage,  $SF = 1.368 < 1.50$
- 2) Construction Stage of Strengthening the Bridge Structure,  $SF = 1.551 > 1.50$ .

It is planned to use a Contiguous Bored Pile Wall with a diameter of 1 meter, a pile length of 30 meters, and concrete quality ( $f_c'$ ) of 30 MPa. To address the landslide, the Contiguous Pile Wall will consist of bored piles with the same diameter and concrete specifications, along with a pile cap to stabilize the retaining wall. After the installation of the bored piles, the safety factor increases to  $SF = 1.551$ , with a total displacement of 0.069 meters, indicating that the structure with the Contiguous Bored Pile Wall is "Safe/High," according to the SNI 8460:2017 standards on Geotechnical Design. Several suggestions for further research on the handling of damage to the Glendeng Bridge Abutment include evaluating alternative materials for bridge rehabilitation to optimize cost and efficiency in the budget planning process, ensuring a thorough understanding and study of any software program used in research and analysis to facilitate smoother implementation.
