ANALYSIS OF ROAD DAMAGE USING THE PAVEMENT CONDITION INDEX METHOD ON THE LAMONGAN CITY – MOJOKERTO BORDER ROAD SECTION

Abstract

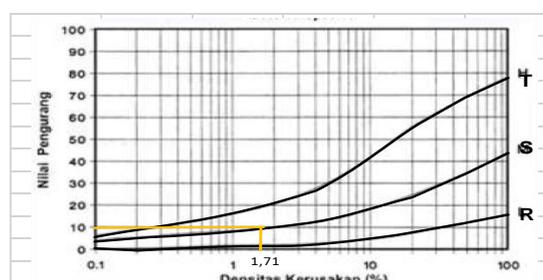
**Figure 1. Reduction Value of Medium Severity Chipped Aggregate**

In Figure 1 above, the result of the relationship between the damage density of 1.171% and the chipped aggregate damage graph results in a deduct value of 10.

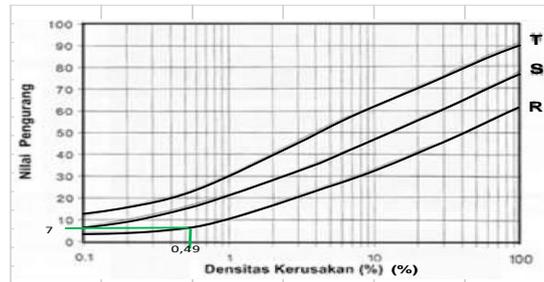
Source: Processed by Researchers, 2024
Figure 2. Reduction Value of Low Severity Alligator Cracks

In Figure 2, the results of the 0.49% crocodile crack damage density relationship are drawn vertically until they intersect the crack severity line (R) and then a horizontal line is drawn to determine the deduct value of 7.

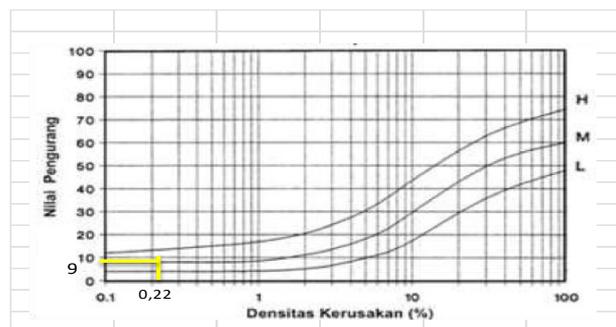
Source: Processed by Researcher, 2024
Figure 3. Deduct Value for Ambles of Medium Severity

In Figure 3, the results of the 0.22% subsidence damage density relationship are drawn vertically until it intersects the medium graph (M) after which it is drawn horizontally until it determines the deduct value of 9.

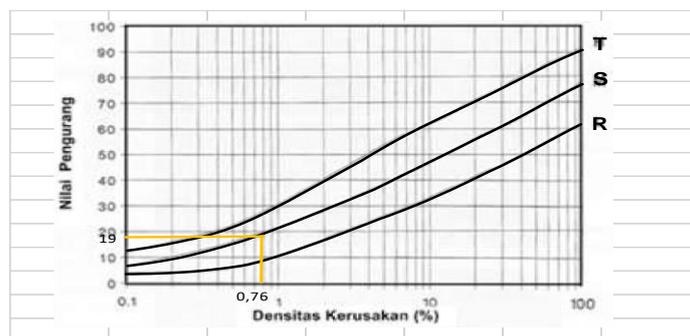
Source: Processed by Researchers, 2024
Figure 4. Deduct Value of Medium Severity Alligator Cracks

In Figure 4 above, the density value of 0.76% is drawn vertically until it intersects the medium severity line (S) and then drawn horizontally to determine the deduction value of 19.

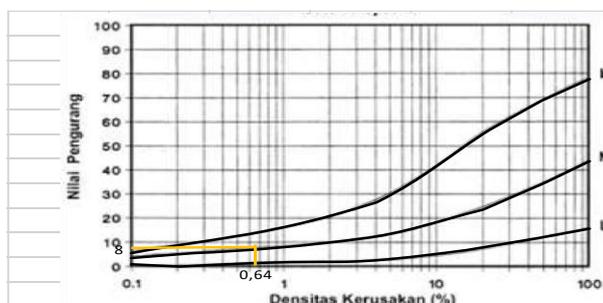
Source: Processed by Researcher, 2024
Figure 5. Deduct Value of Medium Severity Chipped Aggregate

In Figure 5, the medium severity chipped aggregate density of 0.64% is drawn vertically until it intersects the medium severity line (S) and then horizontally until it determines the dedut value of 8.

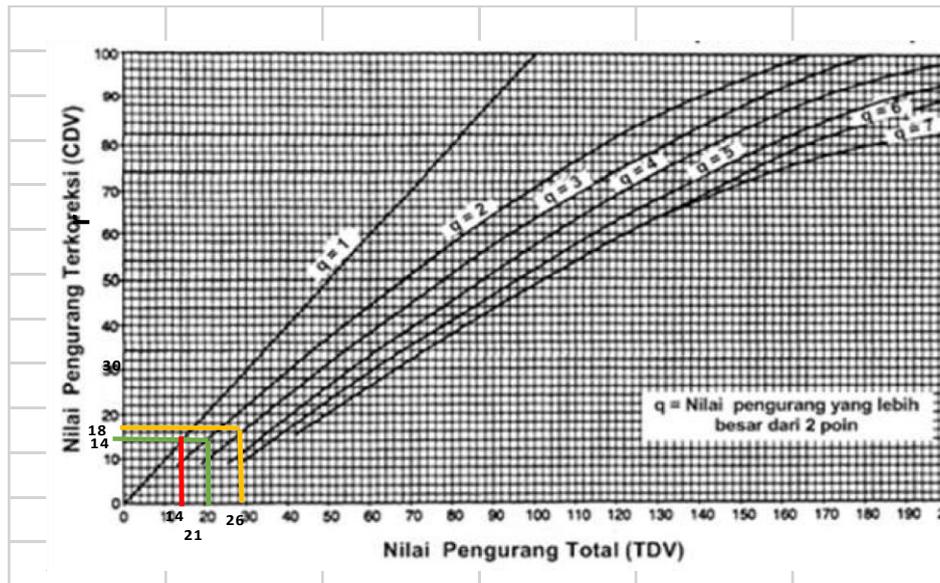
Source: Processed by Researchers, 2024
Figure 7. Corrected Reduction Value (CDV)

In Figure 7 the total deduction value of 14 is drawn horizontally in red until it intersects the q1 line then horizontally drawn in red until the corrected deduction value of 14, the total deduction value of 21 is drawn vertically in green until it intersects the q2 line then horizontally drawn until the corrected deduction value of 14, the total deduction value of 26 is drawn vertically in yellow until it intersects q3 then horizontally drawn until the corrected deduction value of 18. So the maximum corrected deduction value of segment 1 is the value of 18 with q equal to 3.

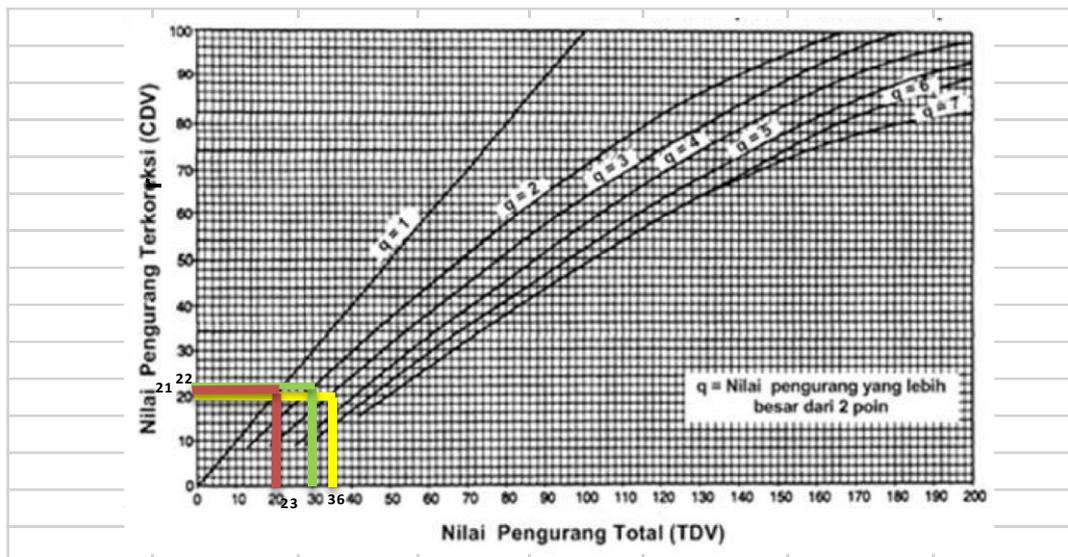
Source: Processed by Researchers, 2024
Figure 8. Corrected Reduction Value (CDV)

In Figure 8, the total subtractor value 23 is drawn horizontally in red until it cuts the q1 line then horizontally drawn in red until the corrected subtractor value 21, the total subtractor value 30 is drawn vertically in green until it cuts the q2 line then horizontally drawn until the corrected subtractor value 22, the total subtractor value 36 is drawn vertically in yellow until it cuts q3 then horizontally drawn until the corrected subtractor value 20. So the maximum corrected subtractor value of segment 1 is the value 22 with q equal to 2.
