Alternative Design of Abutment Damage Management for Glendeng Bridge Tuban Regency

Alfanditya Ghazanfar^{1*}, Moh. Muntaha², Machsus Machsus³

¹⁻³Master of Applied Study Programme in Engineering Maintenance and Restoration of Civil Structures Study Program Departemen Civil Infrastructure Engineering, Faculty of Vocational Studies, Institut Teknologi Sepuluh Nopember, Surabaya Indonesia

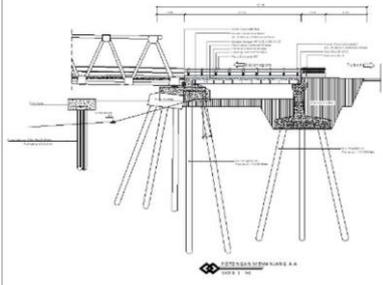
Table 6. Results of Analysis of Alternative Handling of Damage to Glendeng Bridge

No.	Load Input	Water Level from the Top of the Bridge (m)	Safety Factor	Slope Stability SF > 1 to 1.5	Description
1.	Bridge Construction Stage	-2,8	1,368	< 1,5	Not safe
2.	Reinforcement Construction Stage	-2,8	1,551	> 1,5	Safe

Based on the results of the analysis of the existing Plaxis software used in the analysis of this alternative treatment using the existing 2021 reinforcement which was damaged and resulted in a value of SF = 1.097 at the construction and embankment stages but the increase in the safety factor after bored pile was implanted as an alternative treatment was SF = 1.551 and the total displacement that occurred was 0.069 m, indicating that the reinforcement structure using Contiguous Bored Pile Wall can be categorized as "Safe / High" according to SNI - 8460 of 2017 concerning "Geotechnical Planning" this handling is also more economical only spending a budget of ± 3 billion Rupiah.
