# Alternative Design of Abutment Damage Management for Glendeng Bridge Tuban Regency

**Alfanditya Ghazanfar<sup>1\*</sup>, Moh. Muntaha<sup>2</sup>, Machsus Machsus<sup>3</sup>**

<sup>1-3</sup>Master of Applied Study Programme in Engineering Maintenance and Restoration of Civil Structures Study Program Departemen Civil Infrastructure Engineering, Faculty of Vocational Studies, Institut Teknologi Sepuluh Nopember, Surabaya Indonesia

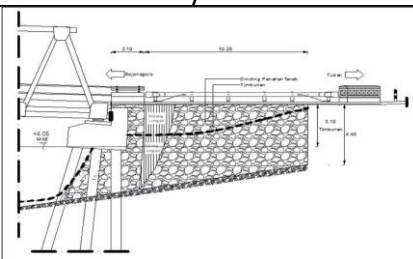
**Table 2. Results of Stability Analysis of Initial Conditions in 2020 (Before Flood)**

Based on the results of the above analysis, the value of  $SF = 1.443$  is obtained in the analysis of the operational stage of the load with conditions when the flood water level (HWL) while in the operational stage of the load with normal water level conditions, the value of the

safety factor decreases  $SF = 1.347$  the increase in the SF value during flood conditions lies in the flood water elevation factor. The high water level elevation will increase the hydrosecurity pressure acting on the river cross section, thus increasing the magnitude of the resisting force element in resisting the driving force element in the form of soil mass from the river slope.

The comparison graph above is the result of the Plaxis software analysis at all stages of the pre-flood condition analysis or under normal conditions with the existing parameters showing that none of the stage conditions reach the  $SF = 1.5$  value so that the existing conditions in 2020 already have a low SF value.

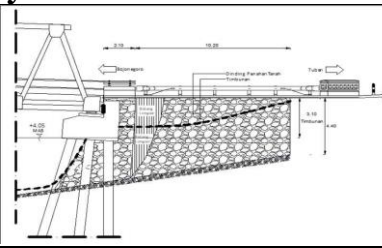
**Table 3. Results of Stability Analysis of Conditions After Flooding in 2020 (After Flood)**

Based on the results of the above analysis, the value of  $SF = 1.052$  is obtained in the analysis of the operational stage of the load with conditions when the water level is flooded (HWL) while in the operational stage of the load with normal water level conditions, the structure experiences landslides when it is noted that landslides occur when the water level is normal, this is because there is a factor that is rapid drawdown so that it can affect the stability of the slope and surrounding structures. Rapid drawdown is a rapid decrease in water level elevation that affects the condition of slopes and nearby structures. This decrease can leave a saturation effect on the soil so that the soil parameters are assumed to decrease and overload the retaining wall structure, causing landslides.

- 1) After the flood event (HWL) bridge construction stage,  $SF = 1.218$
- 2) After the flood event (HWL) load operational stage,  $SF = 1.052$
- 3) After flood event (LWL) bridge construction stage,  $SF = 1.134$
- 4) After the flood event (LWL) load operational stage, structural failure occurs

The comparison graph above is the result of the Plaxis software analysis at all stages of the condition analysis after a flood or with the existing parameters showing the load stage experiencing landslides when the spring water is in the normal water level  $SF = -$  so that this existing condition correlates with the evaluation related to damage in 2020, namely the elevation of the flood water level affects the resistance force on slope stability. When the water level drops suddenly or rapid drawdown, landslides occur because the soil properties have changed to saturation due to the flooding that occurred.

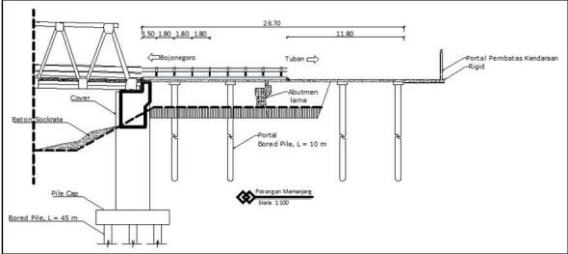
**Table 5. Stability Analysis Results of Reinforced Condition 2022**

Based on the results of analyzing the stability of the bridge structure under reinforced conditions in 2022 at each stage, the safety factor value is obtained as follows:
