## ARRANGEMENT OF PEDESTRIAN PATHS BASED ON WALKABILITY ASPECTS IN JAKARTA KOTA TUA AREA

Keywords: Pedestrian-path, Walkability, Jakarta Kota Tua (Old Town), Public Facility

This research was conducted in Kota Tua Jakarta, which is located in Pinangsia Village, Tamansari District, West Jakarta Municipality. This study area has an area of 1.3 km<sup>2</sup> consisting of 18 corridors. The research method used in this study is quantitative research where quantitative in this study aims to explain the results of the pedestrian path assessment with a walkability index.

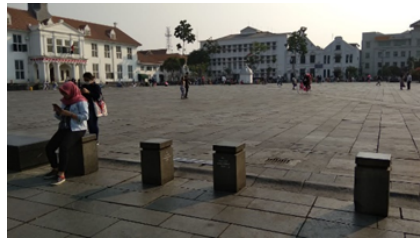
**Figure 4** Seating in 5<sup>th</sup> Segment

At some point in each segment in the Kota Tua area, they already have lighting for pedestrians, especially in the area around the Fatahillah Museum. The function of the lighting itself is to provide lighting for pedestrians, especially at night. However, these lamps are not available in the 12A and 13A segments. The availability of seating facilities in the Kota Tua area is quite a bit. This can be seen from its availability which is only around the historic building of the Kota Tua itself (Figure 4).

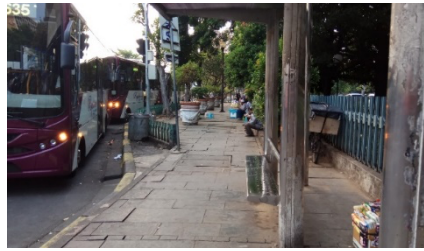
**Figure 7** Guardrail in 13<sup>th</sup> Segment

A bus stop is a stopping place that generally has a waiting room with a roof, but is smaller than a terminal. There are only a few bus stops in the Kota Tua area, namely 1<sup>st</sup> and 4<sup>th</sup> segments. Most of the bus stops in the Kota Tua area are still suitable for use.

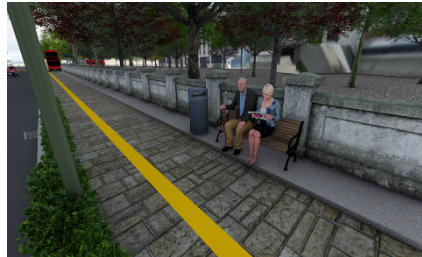
**Figure 9** Design of Adding Trash Cans in Segment 1

Based on the results of the (2019) calculation, low values for the amenities/supporting facilities parameters in both zones. In zone 1 (segment 12) and zone 2 (1<sup>st</sup>, 4<sup>th</sup>, 9<sup>th</sup>, 10<sup>th</sup>, 11<sup>th</sup> and 15<sup>th</sup> segments), the proposed structuring directions are the addition of trash bins, lighting, no-parking and no-stop signs, and safety fences.

| 2. | Amenity/support facilities (x6) | Based on observations, the supporting facilities in segment 12 are still very lacking | <p>-The need for additions and trash cans in this segment, especially at the point of stopping public transportation. When viewed from the existing conditions, this segment includes a trade and service area where pedestrians need a place to rest for a while, in addition to the addition of adequate distance seating facilities, namely between seats every 10 meters, adjusted to the guidelines for providing pedestrian space facilities, 2004.</p> <p>-The need for additional trash bin facilities is of course adjusted to the length of the pedestrian path in segment 12 with a distance of 20 meters with a size according to the needs of the existing condition of the pedestrian path in that segment and the materials used have high durability such as metal and cast concrete which are adjusted to the guidelines providing pedestrian space</p> <p>- In terms of lighting, the addition of lights needs to be further developed in terms of quantity and quality which in the</p> | |

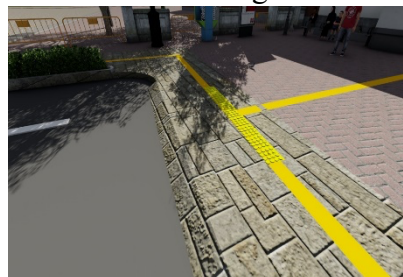
**Figure 11** Design of Disabled Infrastructure Addition in the 1st Segment

Assessments for disabled infrastructure parameters that have low scores are in 5<sup>th</sup>, 6<sup>th</sup>, 7<sup>th</sup> and 18<sup>th</sup> segments, where there are no adequate facilities for people with disabilities. With that, the direction of structuring on aspects of infrastructure for people with disabilities is in the form of adding disabled facilities and ramps. While in zone 2 the lowest values are in 1<sup>st</sup>, 8<sup>th</sup>, 9<sup>th</sup>, 11<sup>th</sup>, 14<sup>th</sup> and 17<sup>th</sup> segments with an average value of 10.

| 3. | Disabled infrastructure (x7) | Based on observations, researchers see that the facilities for pedestrians with disabilities are still relatively low, they are available but the placement is still not right | Additional facilities, disabled people and ramps are needed in every pedestrian path segment. Of course, ramps and markings are located in locations that are safe from vehicle circulation and free of obstacles, should have special markers in the form of colored lines and be directed at points of social interaction so that when viewed from the existing conditions, people with disabilities can easily go to office facilities or trade and service centers. | |

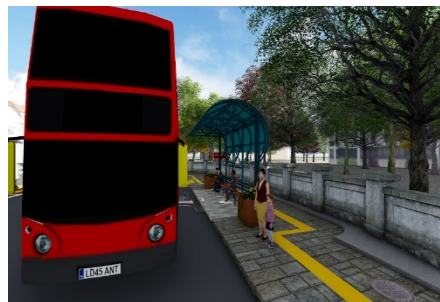
**Figure 12** Bus Stop Design in 1st Segment

Aspects of things that hinder get a low score, in zone 2 9<sup>th</sup> segment with a value of 10. Therefore, it is necessary to guide the arrangement, namely widening and repairing the surface of the pedestrian path, ramp sloping, cleaning garbage and adding vegetation and then providing complementary facilities, especially lighting, trash cans and more.
