## ARRANGEMENT OF PEDESTRIAN PATHS BASED ON WALKABILITY ASPECTS IN JAKARTA KOTA TUA AREA

### Abstract

Keywords: *Pedestrian-path, Walkability, Jakarta Kota Tua (Old Town), Public Facility*

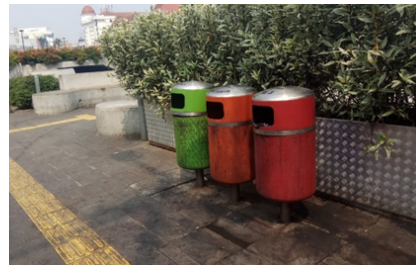
**Figure 5** Trash Can in 8<sup>th</sup> Segment

Most of the trash cans scattered in the Kota Tua area are provided by the government, which is part of the trade and service facilities in the Kota Tua area. Therefore, the trash cans provided have provided waste sorting according to the type of waste and are in segments 8 and 9.

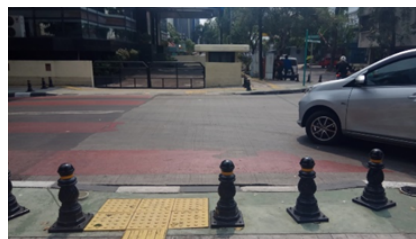
**Figure 6** Guardrail in 13<sup>th</sup> Segment

However, in 1<sup>st</sup>, 11<sup>th</sup>, 12<sup>th</sup>, 13<sup>th</sup>, 15<sup>th</sup>, and 17<sup>th</sup> segments, garbage was found scattered about because of the unavailability of trash bins. Likewise with information boards which can only be found in 4<sup>th</sup>, 5<sup>th</sup>, 6<sup>th</sup>, and 7<sup>th</sup> segments which already meet the standards by placing them at social interaction points. Meanwhile, the availability of safety fences or commonly referred to as barriers is only found at a few points in the Kota Tua area, mainly in the trade and service areas, namely in 1<sup>st</sup>, 9<sup>th</sup> and 13<sup>th</sup> segments (Figure 6).

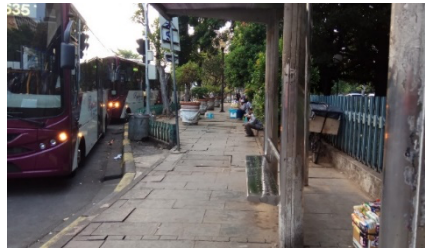
**Figure 7** Guardrail in 13<sup>th</sup> Segment

A bus stop is a stopping place that generally has a waiting room with a roof, but is smaller than a terminal. There are only a few bus stops in the Kota Tua area, namely 1<sup>st</sup> and 4<sup>th</sup> segments. Most of the bus stops in the Kota Tua area are still suitable for use.

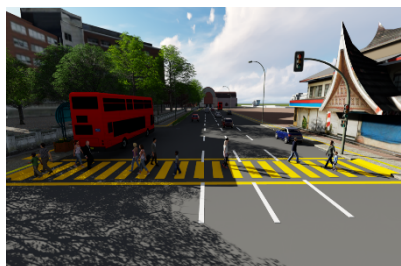
**Figure 8** Crosswalk Design in 1<sup>st</sup> Segment

The safety parameters and availability of crossings, both in zone 1 and zone 2 are considered low due to the absence of crossing paths. Based on the results of the structuring directions, in zone 1 it is necessary to add crossing lanes in 12<sup>th</sup> segment, while in zone 2 the additional lanes are carried out in 1<sup>st</sup>, 4<sup>th</sup>, 9<sup>th</sup>, 10<sup>th</sup>, 11<sup>th</sup> and 15<sup>th</sup> segments.

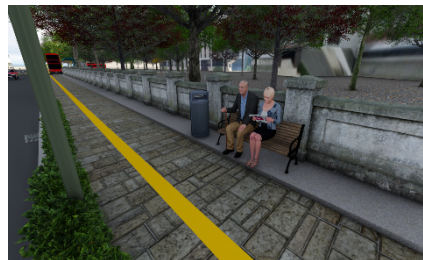
**Figure 9** Design of Adding Trash Cans in Segment 1

Based on the results of the (2019) calculation, low values for the amenities/supporting facilities parameters in both zones. In zone 1 (segment 12) and zone 2 (1<sup>st</sup>, 4<sup>th</sup>, 9<sup>th</sup>, 10<sup>th</sup>, 11<sup>th</sup> and 15<sup>th</sup> segments), the proposed structuring directions are the addition of trash bins, lighting, no-parking and no-stop signs, and safety fences.

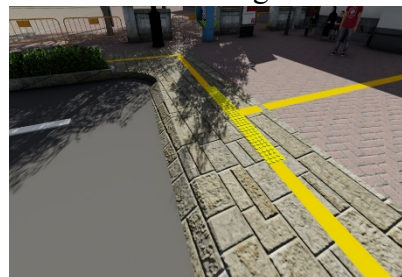
**Figure 11** Design of Disabled Infrastructure Addition in the 1st Segment

Assessments for disabled infrastructure parameters that have low scores are in 5<sup>th</sup>, 6<sup>th</sup>, 7<sup>th</sup> and 18<sup>th</sup> segments, where there are no adequate facilities for people with disabilities. With that, the direction of structuring on aspects of infrastructure for people with disabilities is in the form of adding disabled facilities and ramps. While in zone 2 the lowest values are in 1<sup>st</sup>, 8<sup>th</sup>, 9<sup>th</sup>, 11<sup>th</sup>, 14<sup>th</sup> and 17<sup>th</sup> segments with an average value of 10.

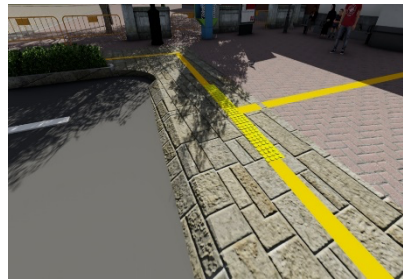
**Figure 11** Design of Addition of Disabled Infrastructure in 1<sup>st</sup> Segment

Assessments for disabled infrastructure parameters that have low scores are in 5<sup>th</sup>, 6<sup>th</sup>, 7<sup>th</sup> and 18<sup>th</sup> segments, where there are no adequate facilities for people with disabilities. With that, the direction of structuring on aspects of infrastructure for people with disabilities is in the form of adding disabled facilities and ramps. While in zone 2 the lowest values are in 1<sup>st</sup>, 8<sup>th</sup>, 9<sup>th</sup>, 11<sup>th</sup>, 14<sup>th</sup> and 17<sup>th</sup> segments with an average value of 10.
